**Flood Control Project Maintenance
Levee Inspections**
LMA District Cover Sheet
Spring 2018 Levee Inspection Results

Reclamation District No. 0556 Upper Andrus

Spring 2018 Levee Inspection Results

Waterway			Bank	Unit Miles
Unit No. 01 Georgiana Slough			Right	5.48
	Spring (March - May)	Summer (June - August)	(September - November) Fall	Winter (December - February)
Unit Maintenance Rating (Fall Only)				
Date of Inspection	4/5/2018 - 4/5/2018			
DWR Inspector	Keith Millard			
Accompanied By	Alan Silva RD 556

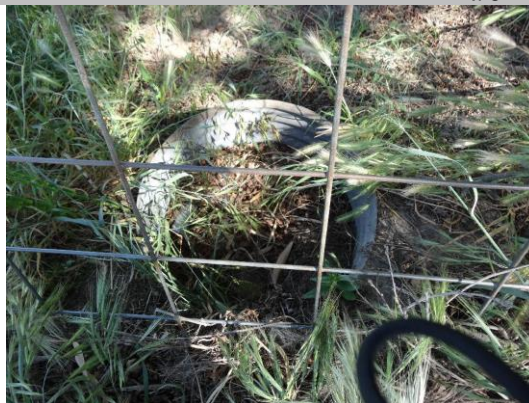
Photo 1 of 3 : UCIP_SP_2018_12547_20320.jpg

Comment Code					
Inspector Comment					
FS_ID:12547 DS_ID:20867 EP_NO: 11199 Repair Type: Non-Urgent Crossing Status: Indicator Found UCIP Comments: - pump, gate valve and pumphouse not found on waterward slope.- an abandoned electric control panel found on WS.- may need to be properly abandoned. FIELD_STRUCT_DESC: 6-inch steel irrigation discharge pipe through the levee, 6.5 feet below the crown. Siphon and concrete spill box with two 8-inch openings. (Retention of a 6-inch pipe through the levee, 6.5 feet below the crown, a pump and a gate valve in a pump house on the waterside [WS] slope, and a siphon breaker and a service pole on the landside [LS] slope authorized under Automatic Board Order (ABO) issued as Permit No. 11199, 1975 - Toshi Tokuyoshi, et al.). [Additional Reference(s): DWR Levee Log. USACE Sacramento O&M Manual 103, June 1954, (Station ""H"" 159+97), invert elevation 17.9 feet]. FS Date: 4/25/2013

LS- obstructed siphon breaker in CMP riser on levee slope.

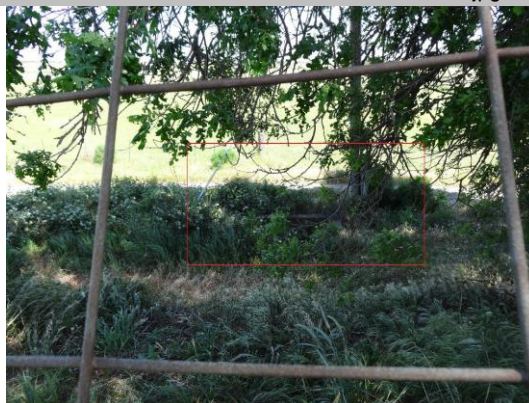
Photo 2 of 3 : UCIP_SP_2018_12547_20319.jpg

LS- concrete distribution box near levee toe.

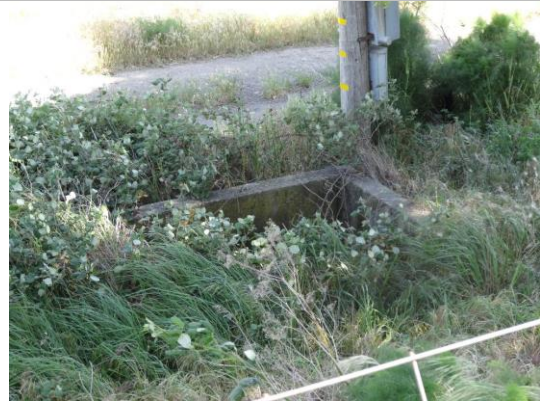
Photo 3 of 3 : UCIP_SP_2018_12547_20318.jpg

Comment Code					
Inspector Comment					
FS_ID:12547 DS_ID:20867 EP_NO: 11199 Repair Type: Non-Urgent Crossing Status: Indicator Found UCIP Comments: - pump, gate valve and pumphouse not found on waterward slope.- an abandoned electric control panel found on WS.- may need to be properly abandoned. FIELD_STRUCT_DESC: 6-inch steel irrigation discharge pipe through the levee, 6.5 feet below the crown. Siphon and concrete spill box with two 8-inch openings. (Retention of a 6-inch pipe through the levee, 6.5 feet below the crown, a pump and a gate valve in a pump house on the waterside [WS] slope, and a siphon breaker and a service pole on the landside [LS] slope authorized under Automatic Board Order (ABO) issued as Permit No. 11199, 1975 - Toshi Tokuyoshi, et al.). [Additional Reference(s): DWR Levee Log. USACE Sacramento O&M Manual 103, June 1954, (Station ""H"" 159+97), invert elevation 17.9 feet]. FS Date: 4/25/2013

LS- power pole and a concrete distribution box near levee toe.

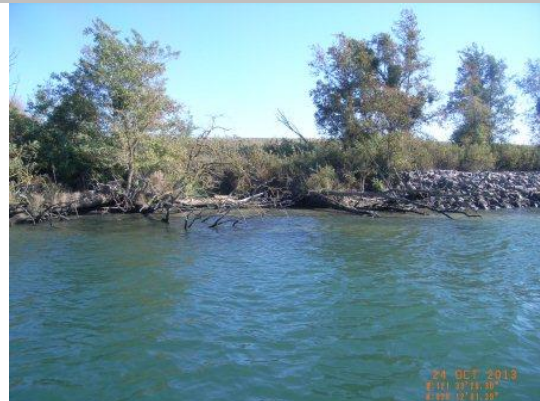
Photo 1 of 1 : SP_2018_RD0556_19_3_20180305_00003.jpg

LM Start	4.77	Rating **	A/W	Issue No.	3
LM End	4.88	Issue Type +	Ma	Location *	WS
Category	Supplemental			GPS Latitude/Longitude	
				Start	End
Item	2015 USACE Erosion Survey, DRAFT			38.201687 °	38.200225 °
				-121.557305 °	-121.557749 °
DWR ID	DWR_RD0556_02_f_2016_3				
Comment Code					
Inspector Comment					
1999 - Downstream 140 ft repaired with rock. 2010 - Lots of woody debris, but no changes to site. 2015: Site extended upstream due to erosion pockets. [2015 Site ID: SAC_21-5_L]

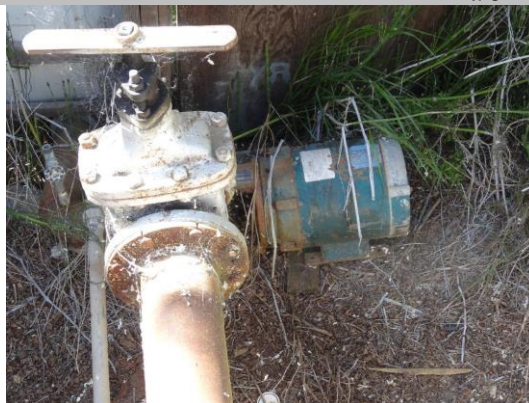
Photo 3 of 3 : UCIP_SP_2018_12564_20351.jpg

Comment Code						
Inspector Comment						
FS_ID:12564 DS_ID:20868 EP_NO: 11191 Repair Type: Non-Urgent Crossing Status: Found UCIP Comments: - needs to fix CMP riser. FIELD_STRUCT_DESC: 8-inch irrigation discharge pipe of an unknown material through the levee, 5.7 feet below the crown. Pump on the waterside (WS) slope. Gate valve on the WS berm. Siphon breaker and service pole on the landside (LS) slope. (Retention of an 8-inch pipe through the levee, 5.7 feet below the crown, a pump on the WS slope, a gate valve on the WS berm, and a siphon breaker and a service pole on the LS slope authorized under Automatic Board Order (ABO) issued as Permit No. 11191, 1975 - Pacific Fruit Exchange). [Additional Reference(s): DWR Levee Log]. FS Date: 4/25/2013

WS- closer look at pump, pipe and gate valve in pump house.

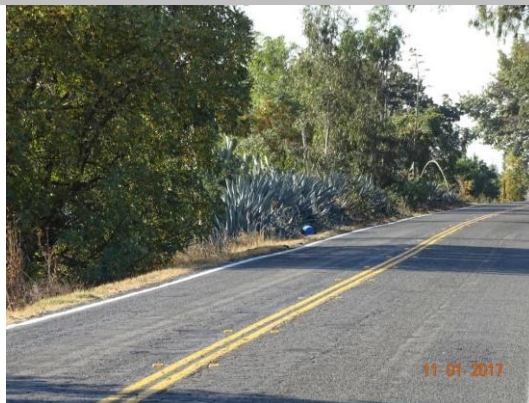
Photo 1 of 1 : SP_2018_RD0556_19_37_20180305_00022.jpg

LM Start	5.08	Rating **	U	Issue No.	37
LM End	5.16	Issue Type +	En	Location *	LS
Category	Earthen Levee			GPS Latitude/Longitude	
				Start	End
Item	Vegetation			38.197407 °	38.196378 °
				-121.558950 °	-121.559601 °
DWR ID	DWR_RD0556_02_f_2017_37				
Comment Code					
V6 : Landscaping					
Inspector Comment

Remove large cactus to allow inspection and access to landside slope and toe.

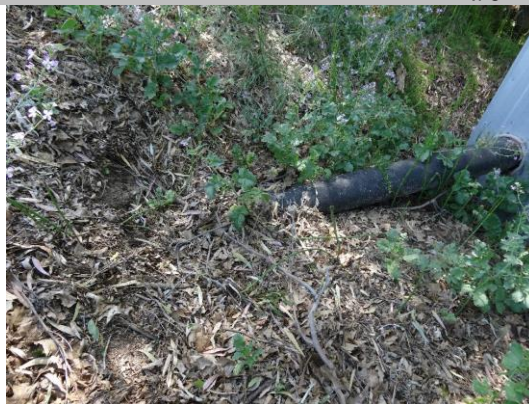
Photo 2 of 3 : UCIP_SP_2018_12570_20363.jpg

WS- pipe daylight from the levee.
